# ***Sinclair Spectrum***

# SERVICING MANUAL

ZX SPECTRUM®

Prepared by THORN (EMI) DATATECH LTD  
for SINCLAIR RESEARCH LTD

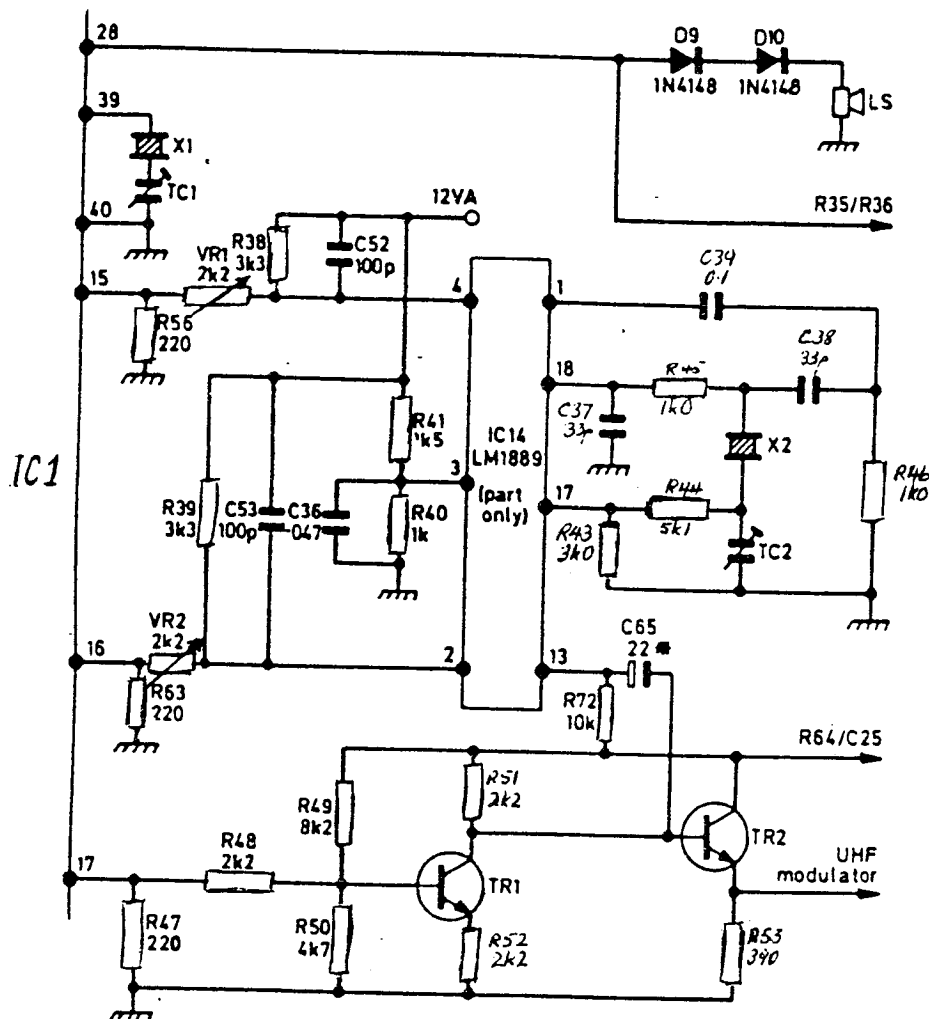
Early circuit showing presets TC1, TC2, VR1 and VR2 to match the early type boards.

Note:- the different pins 16/17 setup from IC1 in the generalised circuit diagram shown in the middle pages.

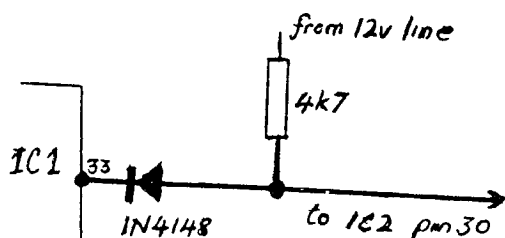
In very versions, instead of TR6 a somewhat unreliable, resistor/diode was used which should be modified as shown in the centre pages.

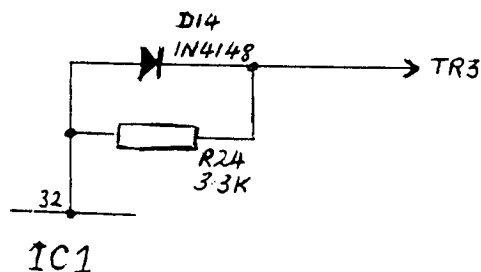
Modifications associated with IC1

This very unreliable circuit was used in very early versions from pin 32 to base of IC1. This circuit should be modified to that shown in the centre pages if not already done.
